## CONSERVATION OF TWO STATUES IN THE TEMPLE OF MUT IN LUXOR, EGYPT

### ABSTRACT

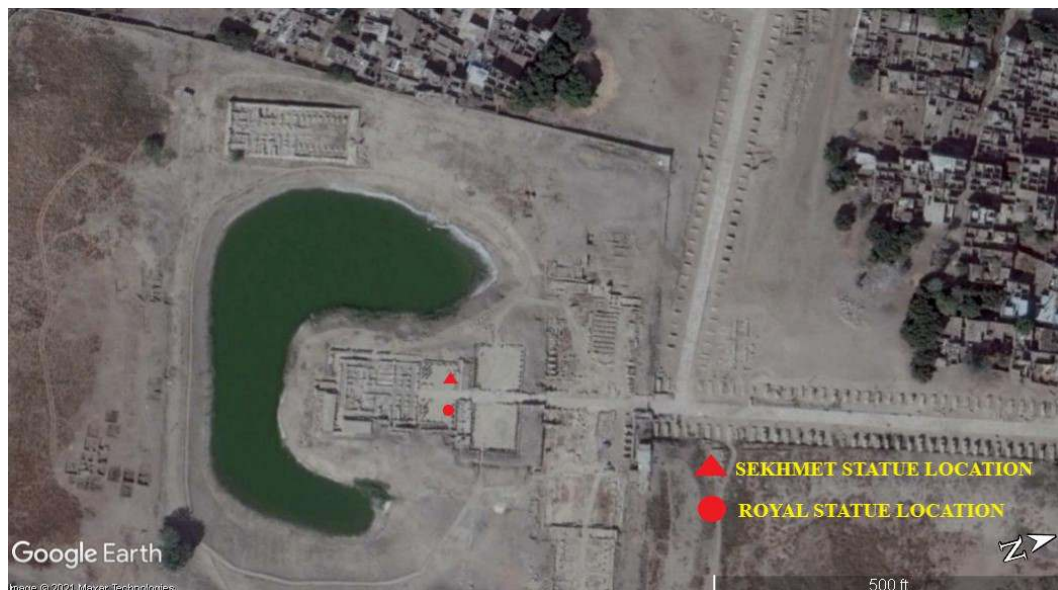
**Figure 1: Location of Statues within the Temple.**

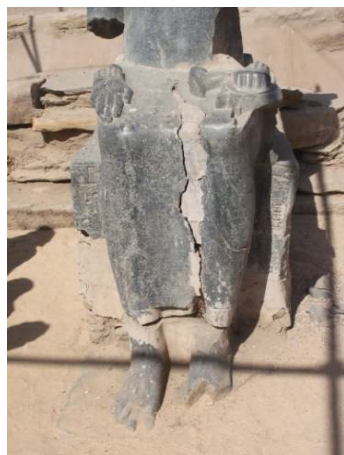
Although Benson and Gourlay did not describe in detail the extent of the "mending" that was performed on the statues, in time, it is suggested that the vertical major crack in the Sekhmet statue lap area (see Figure 4) opened to a magnitude that required some type of patching to assist in holding it together. It was most likely patched by the Egyptian government with oversight of the antiquities but the exact date would be difficult in tracking. Interestingly, the base (seat) of the Sekhmet statue, contained broken fill pieces from various pieces of stone. Many of the larger blocks used for fill are inscribed (see Figure 7). There were also two arm sections of the statue located in the base that was returned to its original position (see Figure 8).

**Figure 4: Vertical Cement Patch**

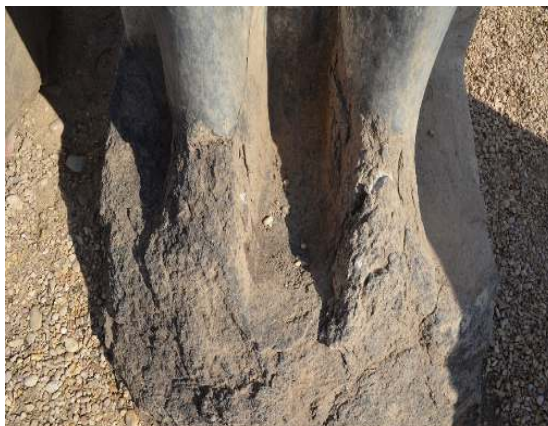
**Figure 5: Examples of Stone Decay on the Statues Sekhmet Statue Lap Area.**

During the dismantling and cement removal, it was found to contain several very thin, corroded metal bars. It was noted that many of the previous cement patches failed, causing large open vertical cracks. Salt efflorescence, in the form of spalling and softening of the stone, was also present in many areas. Wasp and bird nests were also attached to the statues. The work area was covered with canvas to maintain acceptable air temperature so as not to affect the material during conservation.

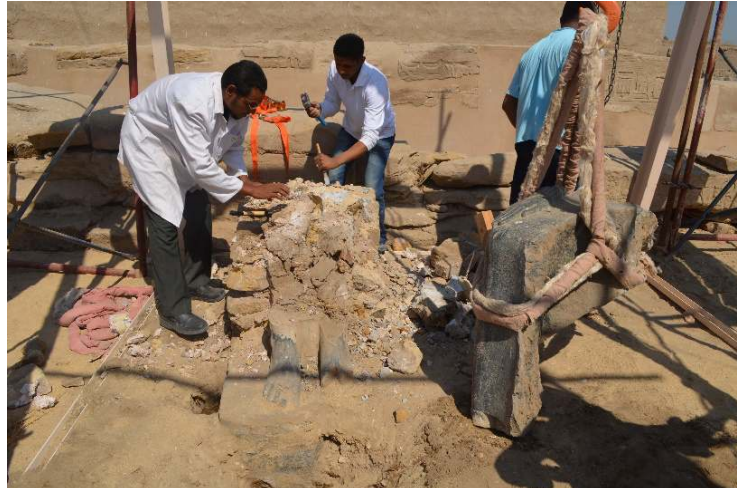
**Figure 6: Sekhmet Statue base Containing Inscribed Blocks and Miscellaneous Fragments.**

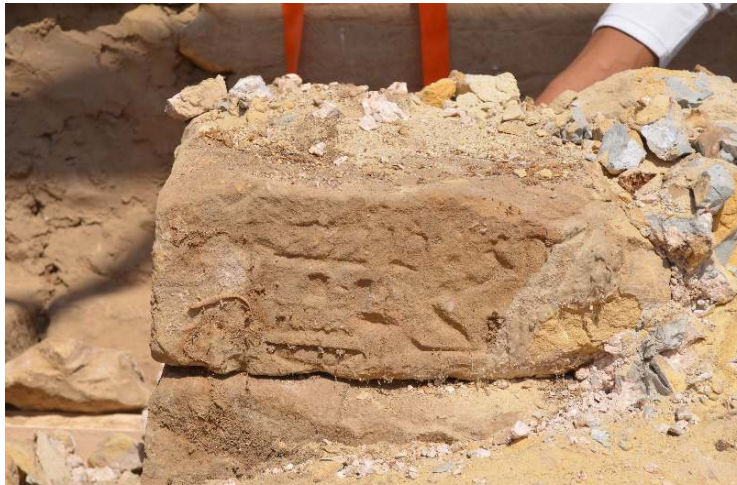
**Figure 7: Inscribed Block Fill found in the Sekhmet Statue base.**

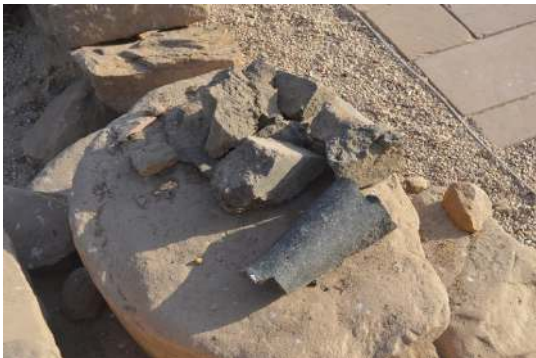
**Figure 8: Fill Pieces Found in the Sekhmet Statue.**

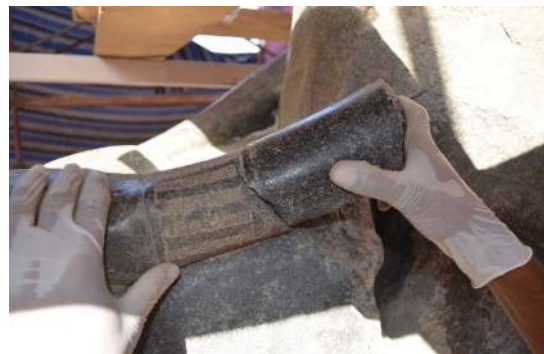
**Figure 9: Showing a Fill Piece Location on the Statue base Arm.**

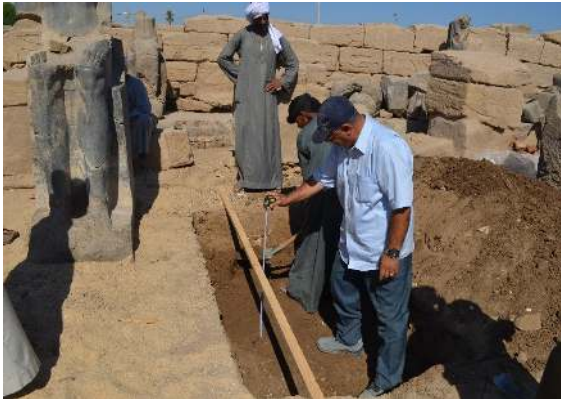
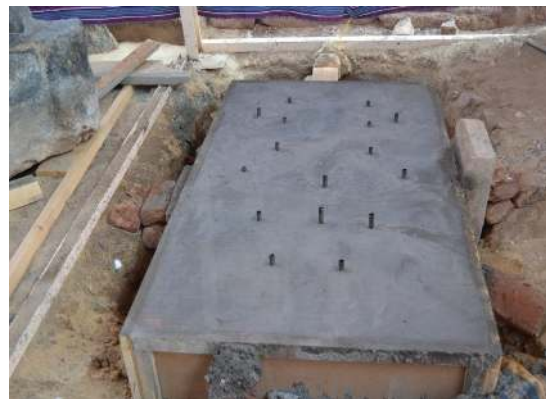
**Figure 10: Excavation for the Sekhmet Statue base    Figure 11: The Completed Concrete base.**

With the statues dismantled, a new reinforced concrete base for the statues was installed (see Figure 11). During the cleaning of the various pieces of the statues, a treatment proposal and plan was generated and the implementation phase started.

The reattachment of the statue pieces on the new concrete support base was systematically performed and fully documented. Several pieces were joined with small reinforcement of stainless steel pins and dowels. This material is resistant to corrosive atmospheric conditions. Cracks were treated and sealed along with miscellaneous patching and re-establishing a statue base using artificial stone. The artificial stone base was a mixture of crushed Granodiorite, Adibond, Glass Sand and Pozzolana.

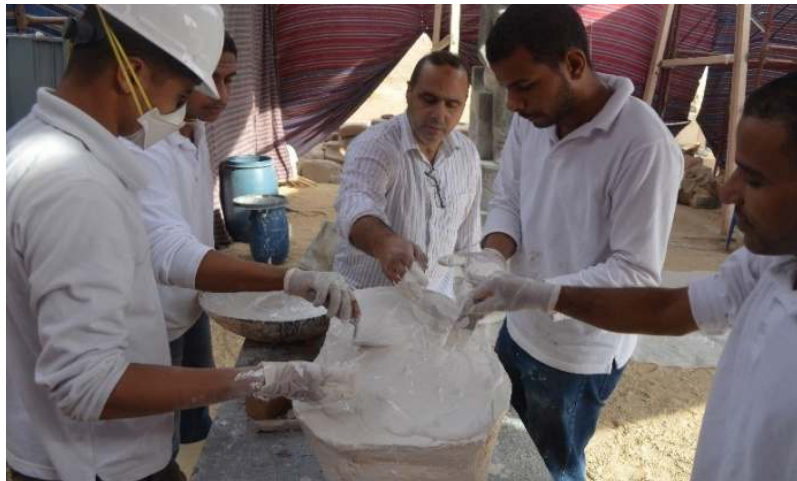
**Figure 12: Students Placing the Plaster Mixture for the Sculpture of the Missing Fragment.**

Moulding was an essential training activity in the ARCE field school. Moulding techniques and applications can support many future conservation activities. With the cleaning, dismantling, repairs and new base complete, it was time for the skilled sculptor to train on the filling in of missing features. This process was led and performed by Dr. Professor Mohamed Shehata from the Faculty of Art, Sculpture Department at Helwan University. Each feature was carefully sculpted based on mirror imaging and filling in remaining parts of the feature. Several materials can be used as the basis for the mould. In our case, plaster was used (see Figure 12). Upon the completion of the plaster feature, a silicone rubber coating was placed over the sculpted piece that would be used as a mould for the artificial stone replacement. The artificial stone was mixed and placed into the silicone rubber mould. The results were a fabricated feature that would be displayed as a completed piece of the original sculpture with an obvious distinct difference in colour and texture (see Figure 13). The field school also used two techniques for the replacement pieces. In the Sekhmet Statue, the artificial pieces were recessed from the original to highlight the differences between the original stone and the artificial stone. In the Royal Statue, the artificial pieces were on the same level with the original stone but the difference between the two materials were visually evident. The other important lesson for the trainees at the field school was that the artificial stone replacement could be

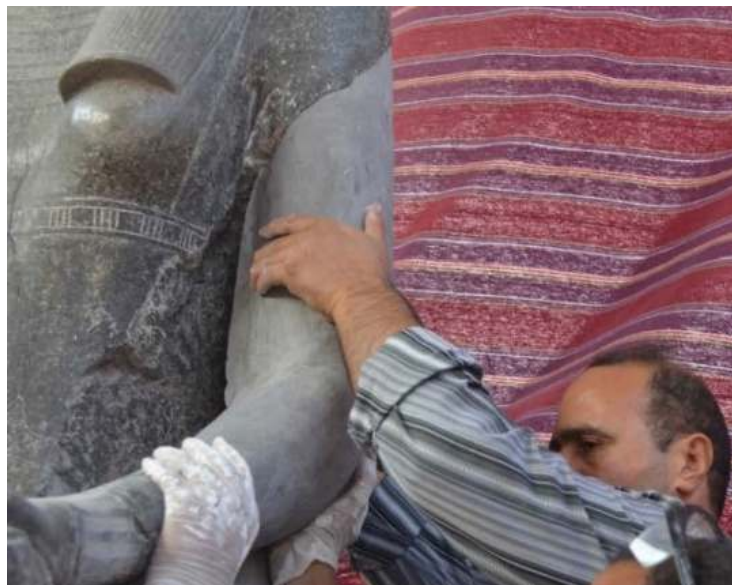
**Figure 13: Dr. Shehata Installing Fabricated Artificial Stone Replacement Piece after Moulding.**

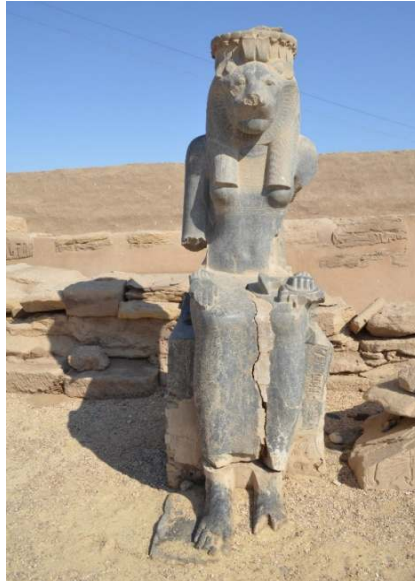
**Figure 14: Sekhmet before Conservation.**

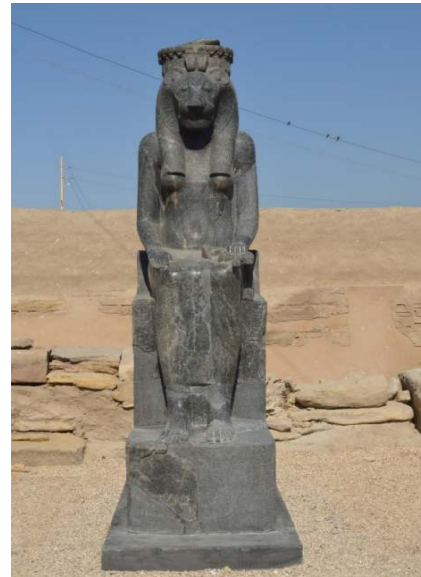
**Figure 15: Sekhmet after Conservation.**

The ARCE Statue Reconstruction Field School under the direction of Dr. Khadija Adam was a complete success. The before and after photos show the remarkable conservation and restoration (see Figure 14, Figure 15, Figure 16, and Figure 17). Some students went on to treat other statues per lessons learned in the field school. The statues stand today as a testament of Egyptian conservation skill as all parties actively involved in the training were Egyptian, supported and financed by USAID in collaboration with the MoTA.

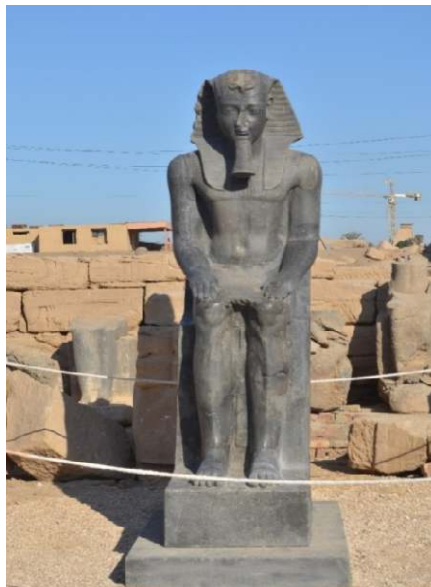
**Figure 16: Royal Statue before Conservation**

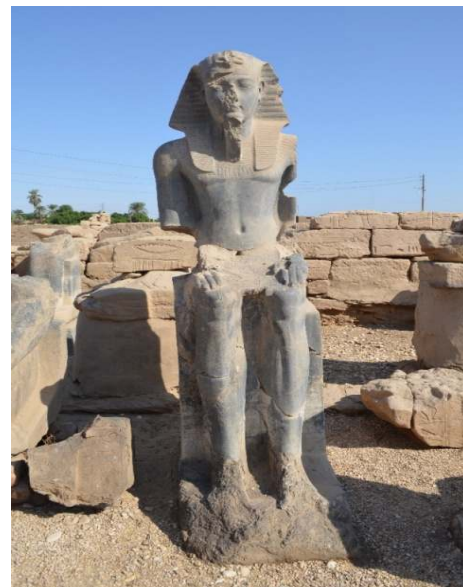
**Figure 17: Royal Statue after Conservation.**
